Case history

TDM 2 helps diagnose a crack on a charge gas compressor

by Fabio H. G. Martins
Maintenance Engineer
Petroquímica União S.A.
and
Rolando G. Dias
Manager/MDS Engineer
Bently do Brasil Ltda.

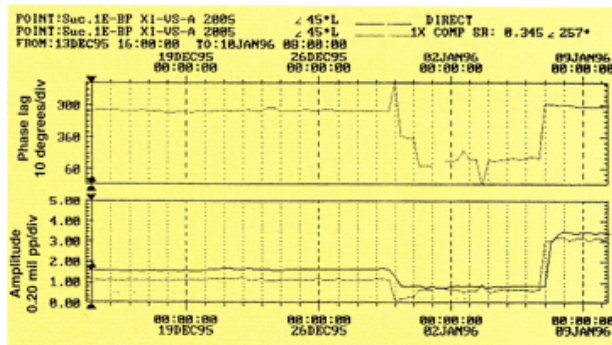
After the last overhaul in 1994, compressor vibration levels had been quite steady and acceptable. However, in late December 1995 and early January 1996, the plant experienced two shutdowns due to operational problems. The compressor was first stopped and then had its speed reduced. After these events, a sudden change was observed in overall vibration levels (Figure 2) in bearing #4.

The problem was diagnosed as a coupling B lockup because the vibration changes were sudden. There was evi-

dence of poor coupling lubrication and excess water, probably due to leakage in the turbine seals. It was recommended that a close watch be maintained. If vibration levels suddenly increased, the machine would be shut down and started up again. The procedure was to attempt a "release" of the coupling, through the axial displacement of shafts during the shutdown and startup.

Figure 2
Bearing #4 vibration trend plot (1X) between
13 December 1995 and 10 January 1996.

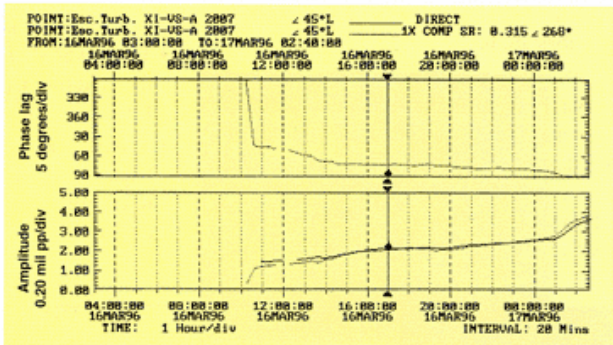
Figure 3
Bearing #2 vibration trend plot (1X).
16 to 17 March 1996.

On March 16th, however, after a boiler shutdown caused an unexpected steam supply upset, fast vibration changes were observed at bearings #2, #3, and #4. At first, we assumed it was another coupling lockup and tried to release it by varying the compressor load and speed. The vibration levels increased, however, and exhibited the following characteristics:

- Predominant 1X vibration, continuously increasing.
- Continuous 1X vibration phase shift (Figures 3 and 4).
- 2X vibration at bearings #2 and #3, suggesting shaft stiffness asymmetry associated with a constant radial load.
- Banana-shaped orbit at bearing #4 (Figure 5), indicating excessive load, possibly due to gross misalignment or coupling lockup, due to poor lubrication.

Editor's Note: Two of the main shaft crack symptoms are 1X vibration change and phase shift. Note that after 20:00, 16 Mar 96, (Figures 3 and 4) the phase remained quite constant. One cause of the continuous phase shift during a shaft crack is the change in the radial direction of the lower shaft stiffness, as the crack propagates. It was already getting close to 50% of the coupling section, so the direction of lower shaft stiffness remained about the same. It is reasonable to conclude that, when the phase stopped shifting, the crack process did not stop. In this case, the crack reached 60% of the coupling section.

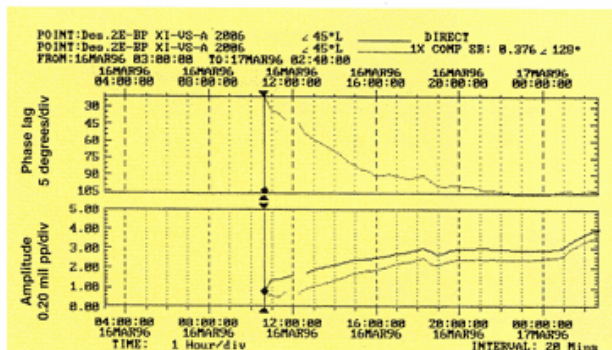
Figure 4
Bearing #3 vibration trend plot (1X).
16 to 17 March 1996.

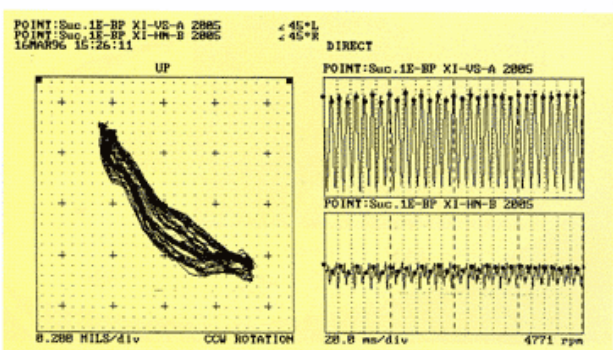
Figure 5
Bearing #4 orbit/timebase plot.
16 March 1996.

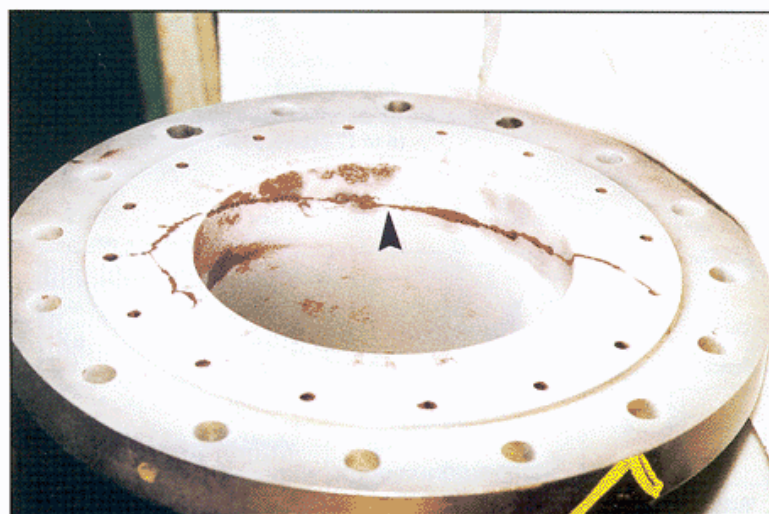
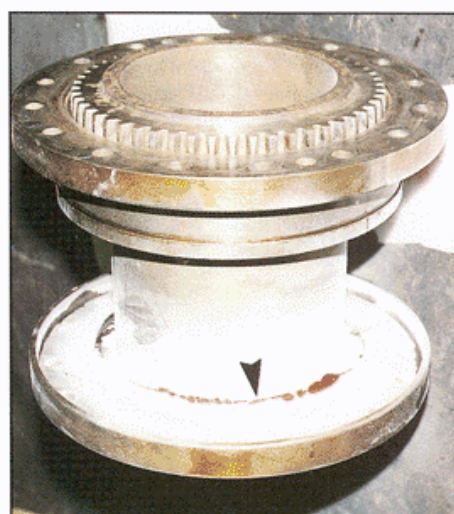
The inspection did find a crack, but in a different component, coupling A. There was a crack through nearly 60% of the coupling section (Figure 6 and 7). A fracture analysis carried out on coupling A showed that the crack was due to fatigue, starting at three different spots.

Coupling B lockup was also confirmed, due to a large amount of oil sludge inside. The same condition was found in couplings A and C.

- Lubrication oil was contaminated with water from a turbine seal leakage, producing oil sludge.
- There was sludge build-up around the coupling teeth, due to centrifugal forces.
- The coupling had locked up and began to act as a rigid body, unable to compensate for the residual misalignment.

- The coupling failed, due to fatigue caused by cyclic forces.

Figures 6 and 7
Internal and external view of cracked coupling. Arrow indicates location of the crack.
